## A polyethylene liner dissociation case report in depuy pinnacle cup. An impingement problem?

### ABSTRACT

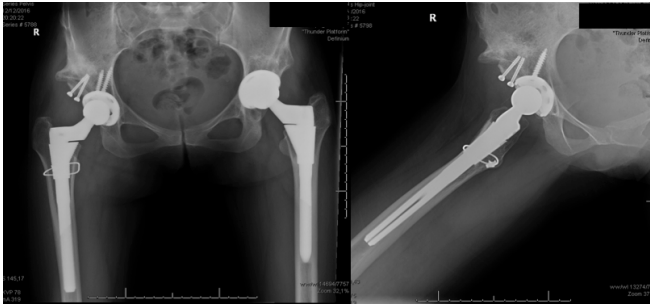
**Figure 1.** X-ray after offset and head replacement.

The patient has operated again, changing S-ROM offset by +8 lateral and a 28mm+3 head. The acetabular cup, or the polyethylene (PE) were not modified. Weight-bearing was allowed since the beginning just taking notice of a leg-length difference of 1 cm due to pelvic tilt (Figure 1).

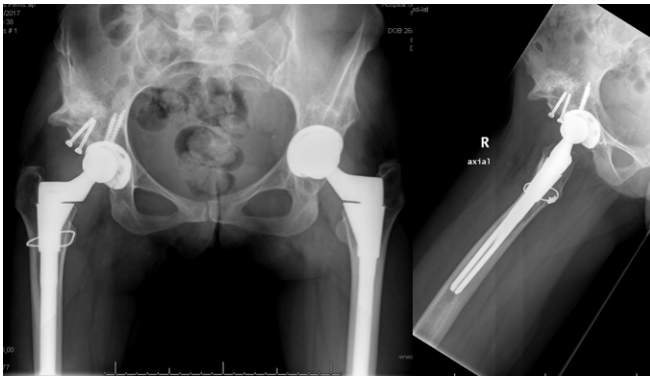
**Figure 2.** Eccentrically positioned head compatible with a polyethylene dissociation.

Twenty-four months after surgery, the patient reports a cracking sound and sudden pain in the groin area with no walking impairment. The X-Ray shows an eccentrically positioned head compatible with a PE dissociation due to a broken PE (Figure 2).

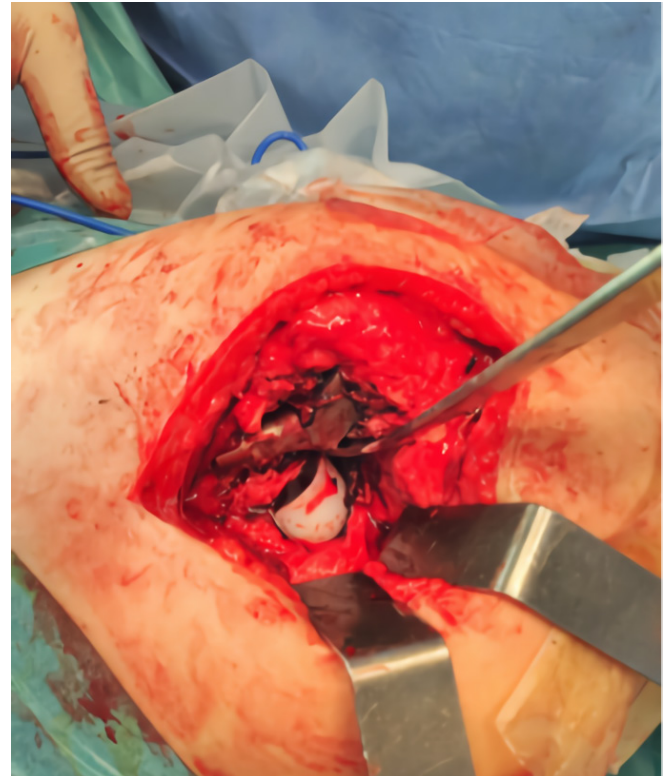
Revision surgery was undergone in December 2017. The surgery discovers a moderate metallosis due to cup-ceramic headwear off. The liner appears dissociated, and four of the six peripheral anti-rotation locks

**Figure 3.** Intraoperative findings. Broken polyethylene.

were broken. The lip was deformed due to neck impingement (Figure 3 and 4). The stem and cup position and fixation is deemed acceptable, and no screw is protruding into the cup. The acetabular blocking system was intact.

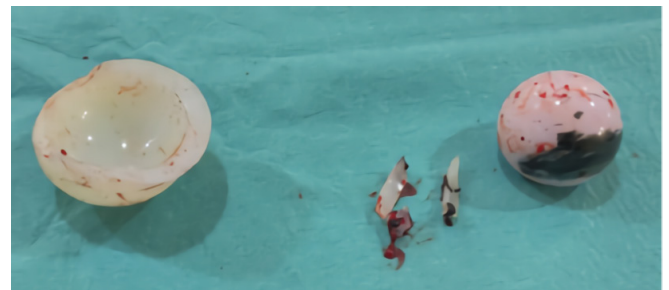
**Figure 4.** The polyethylene lip appears deformed by femoral neck impingement.

In our case, two characteristics make us suspect that failure was caused by impingement between polyethylene and femoral neck. On the one hand, the deformity of the lip, although this fact could also occur after the dissociation of the polyethylene (in the revision surgery the lip had migrated to the lower quadrant of the cup, where it also collided with the femoral neck). On the other hand, the break of the polyethylene locking systems occurred on the opposite side to the lip, the area subjected to greater tension in case of impingement. Several studies have identified the posterior aspect of the cup as the main femoroacetabular impingement point [9]. No other possible causes were found. The patient did not present an excess of physical activity, did not perform impact sports activity or suffered any trauma, the acetabular screws did not protrude, and a poor assembly when inserting the polyethylene is unlikely since the disassociation occurred after 24 months.

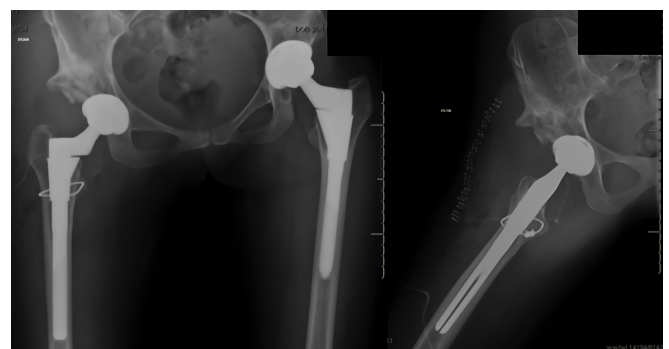
**Figure 5.** X-ray after last surgery.

A neutral ceramic liner and a 28mm +6 ceramic

head were implanted; no impingement was found after reduction. The patient was discharged after seven days (Figure 5). Normal weight-bearing was allowed after four months. Currently, one year after last surgery, the patient has no pain, has a functional range of motion, and maintains a pelvic tilt of 1 cm.
